**Infrared Inspection Report
Roof Moisture**

**Local University
Scholar Drive
Hometown, NJ 11111**

**Mess Hall
Food Line
Hometown, NJ 11111**

THERMOGRAPHER'S COMMENTS
OUR JOB NUMBER: EDU444-11

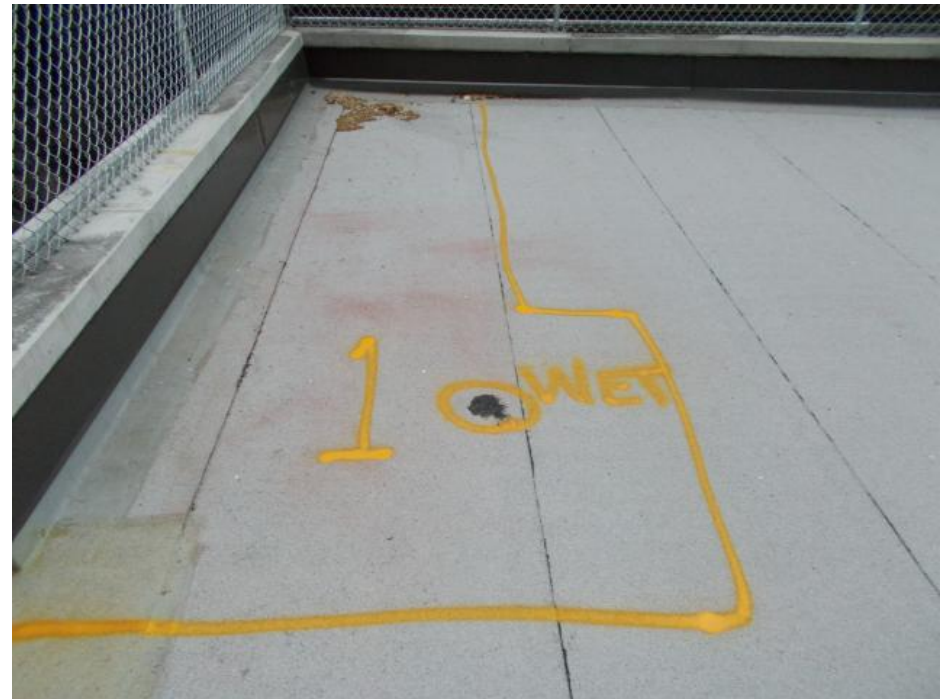
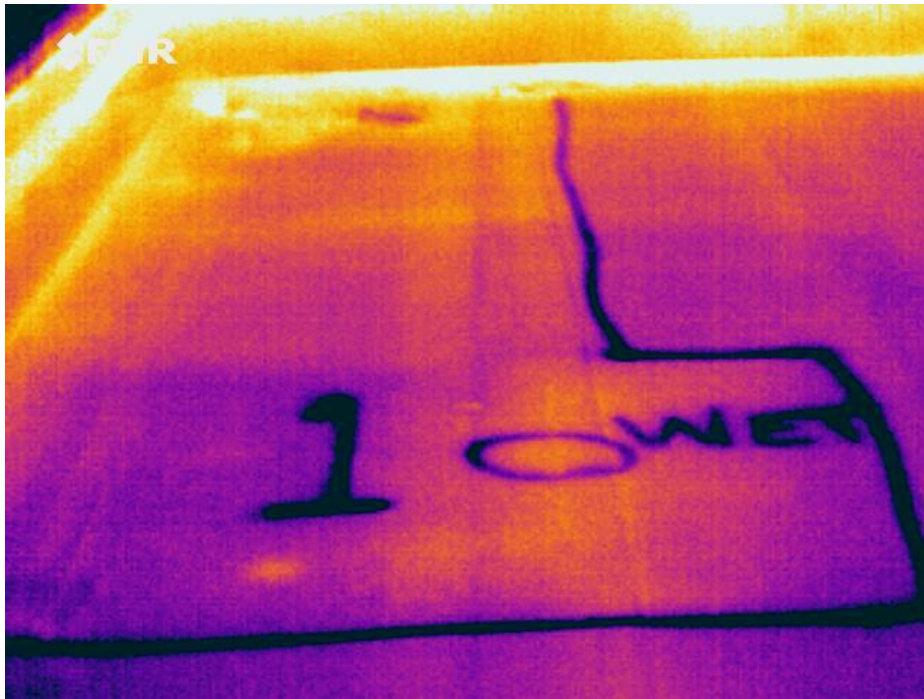
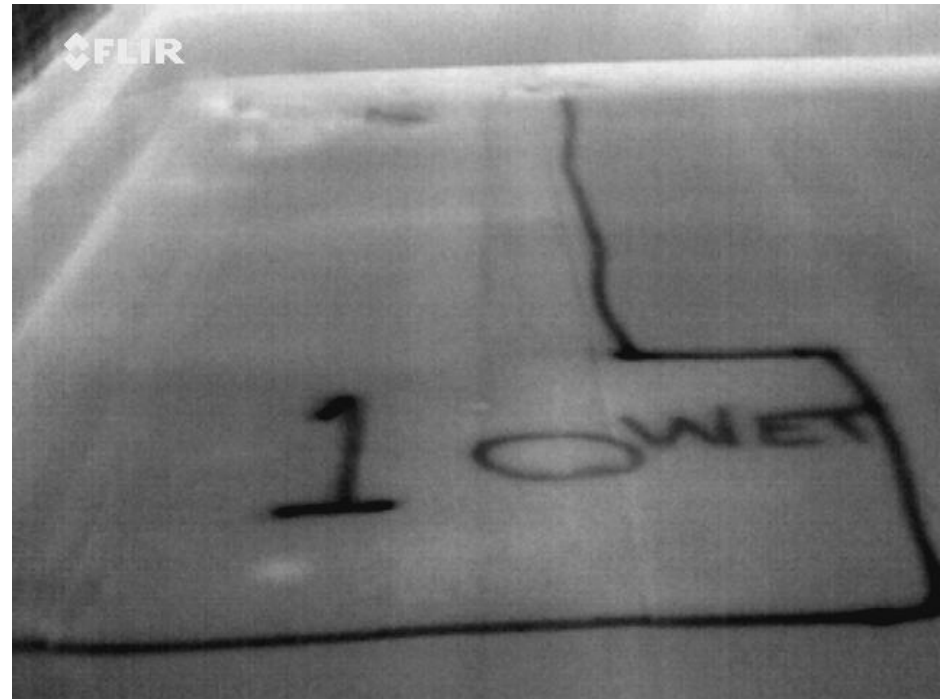
Area/Image No. 1 **Job No.** EDU444-11

Damage Type Moisture **Ambient Temp** 65 °F **Subj. Priority**

Overall Size: 24 sf

Previously Patched: Yes

Moisture Probe: Positive

Comments Areas contains pockets of moisture damaged insulation.

RECOMMENDATIONS: We recommend that the moisture-damaged area(s) be ripped up and replaced. Should a decision be made to replace only the moisture-damaged area(s), an area at least one foot wider than the painted outlines should be replaced to ensure that all moisture damage is removed. Since some of the area(s) may enlarge by the time repairs are made, the roofer should remove all moisture damage found.

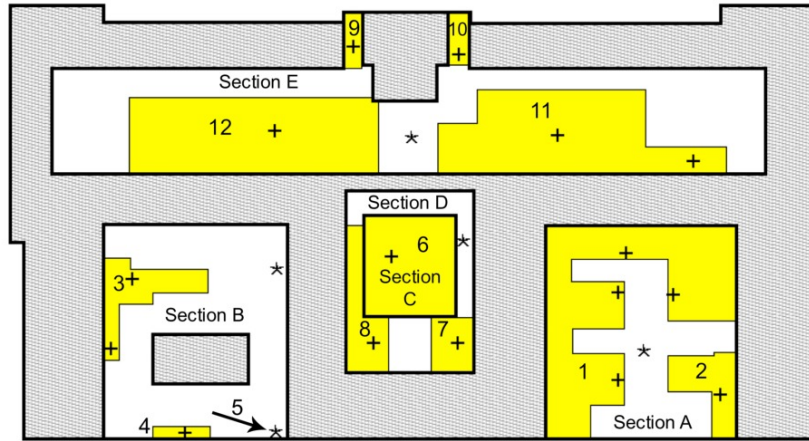
This report contains a scaled map of the roof with the moisture-damaged areas marked in yellow. These yellow areas correspond to the areas of the roofing system that contain moisture. All moisture-damaged areas of the roof are outlined with yellow spray paint on the roof surface. Also included in this report are Thermograms and control photographs of the moisture-damaged areas.

Section A: 33.9%
