## **INFRASONIC™ STEAM SURVEY**

*ABC Company  
123 Main Street  
Anytown, USA*

*February 19, 2013*

*Our Job Number: 13-1479.37*

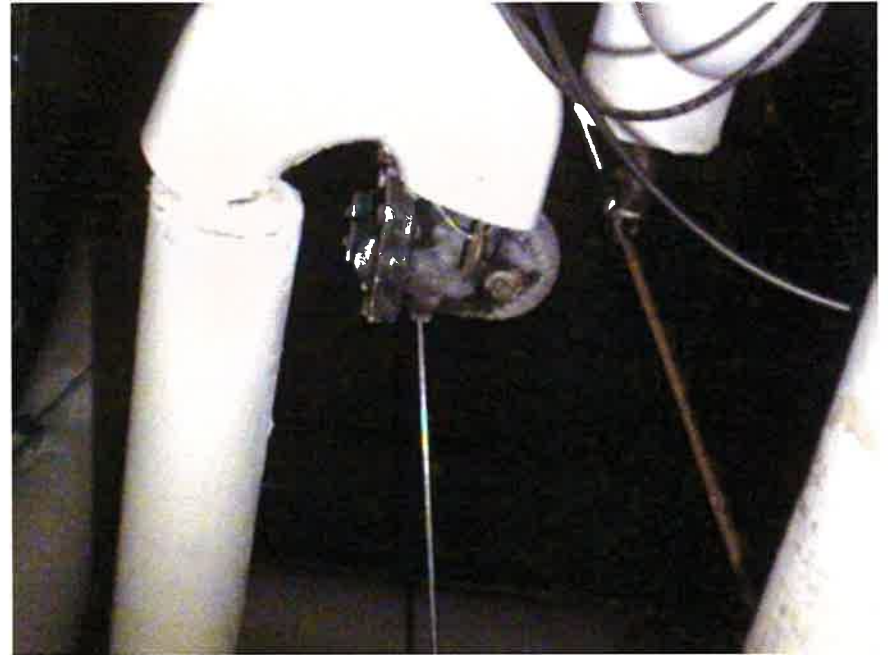
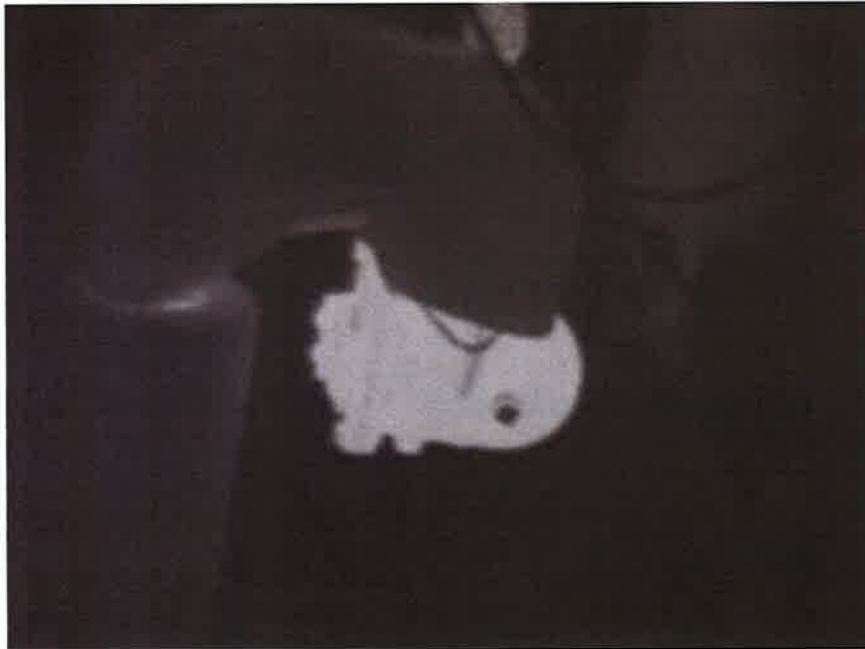
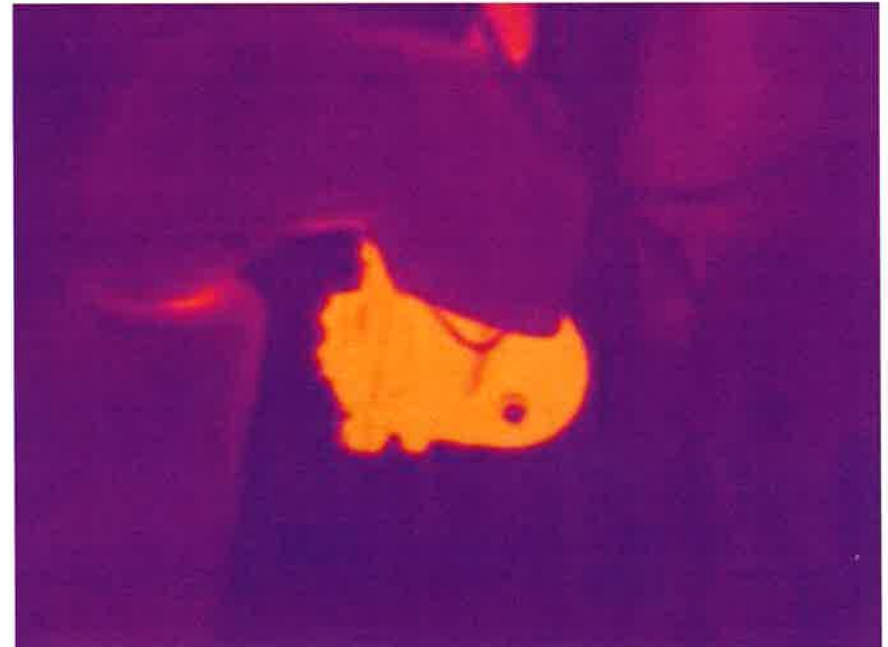
Area/Picture No. 1 Job No. 13-1479.37 Date 2/19/13

Location L23N Business

Equipment Steam Trap #14

Comments Trap Temperatures:

Inlet	Outlet
216°F	216°F

Note: Ultrasonic unit detected steam passing.

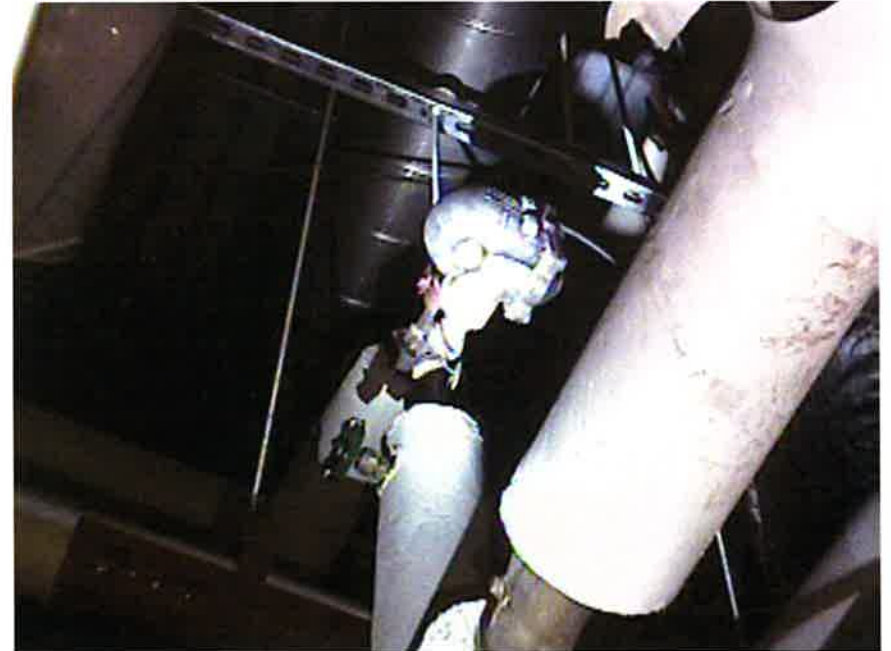
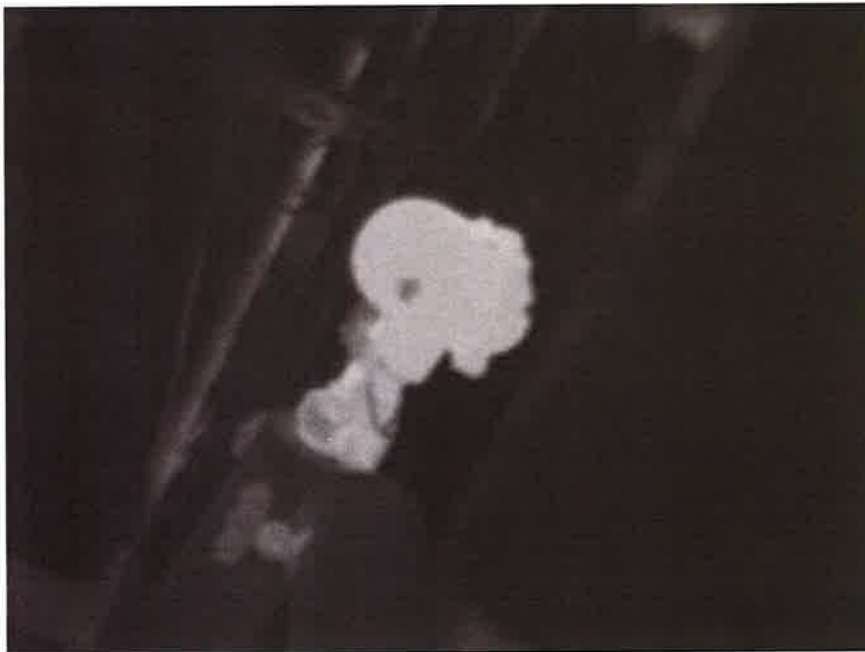
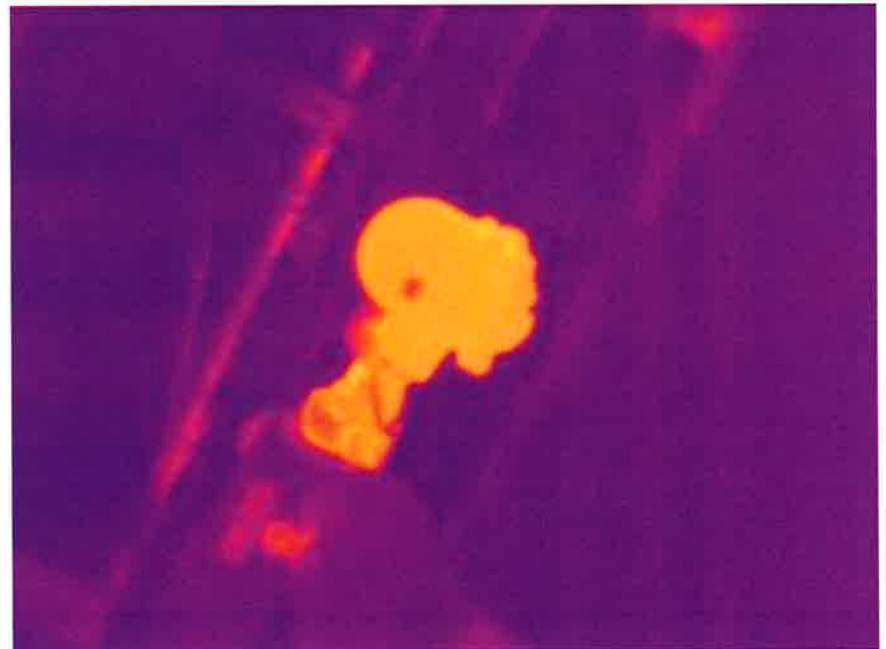
Area/Picture No. 2 Job No. 13-1479.37 Date 2/19/13

Location L13N, Cubicle Ceiling

Equipment Steam Trap #21

Comments Trap Temperatures:

Inlet	Outlet
216°F	212°F

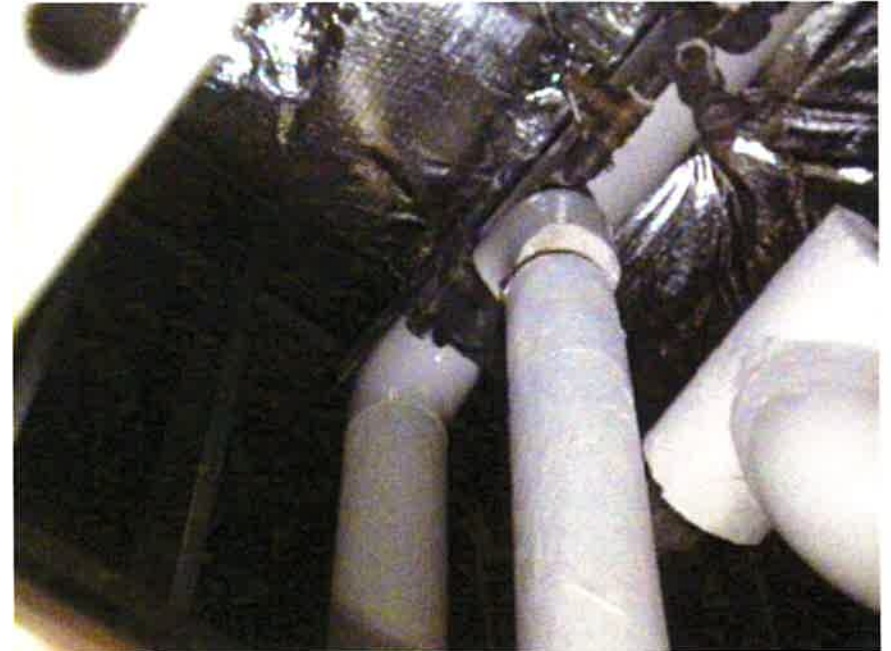
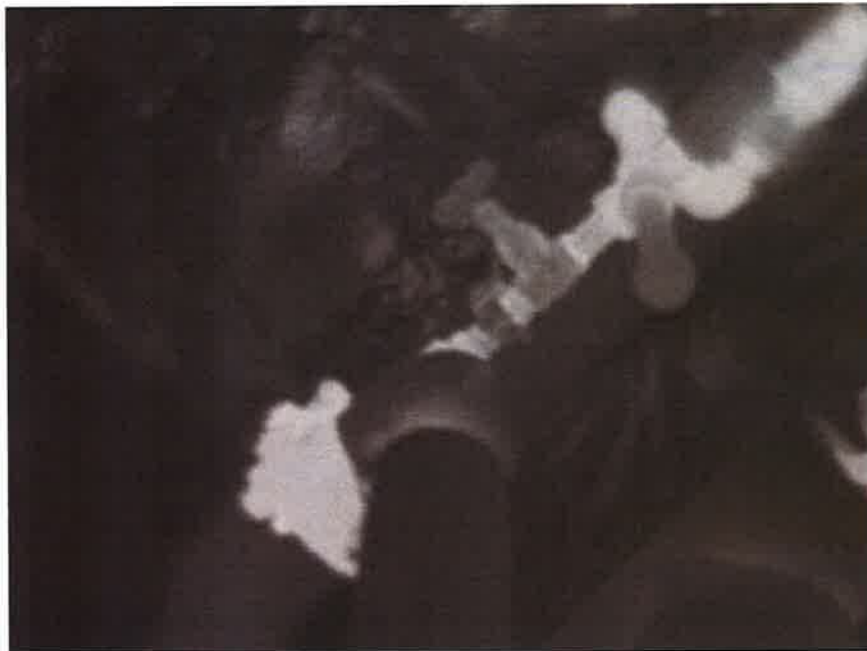
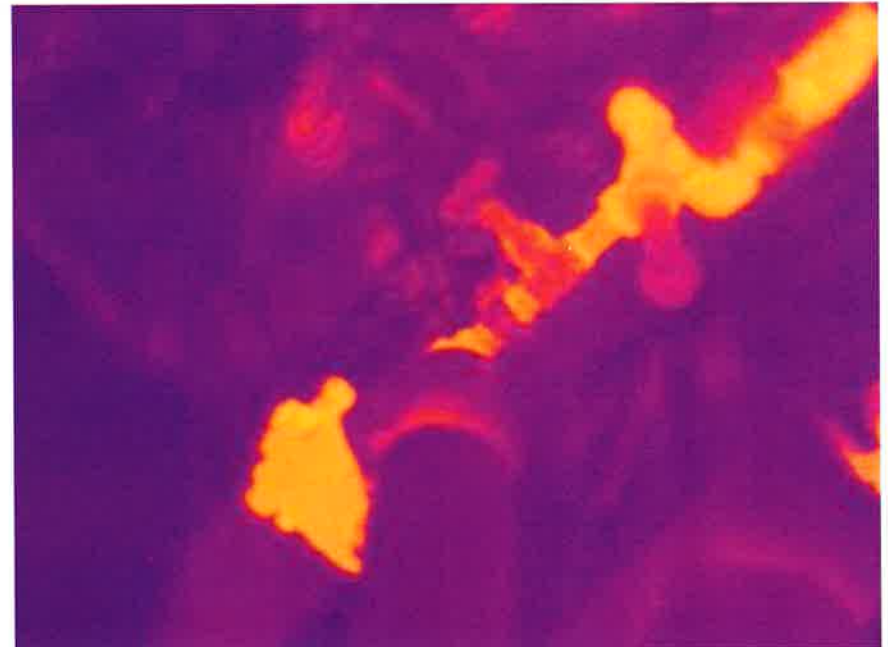
Area/Picture No. 3 Job No. 13-1479.37 Date 2/19/13

Location L08N, Hallway Ceiling

Equipment Steam Trap #26

Comments Trap Temperatures:

Inlet	Outlet
221°F	214°F

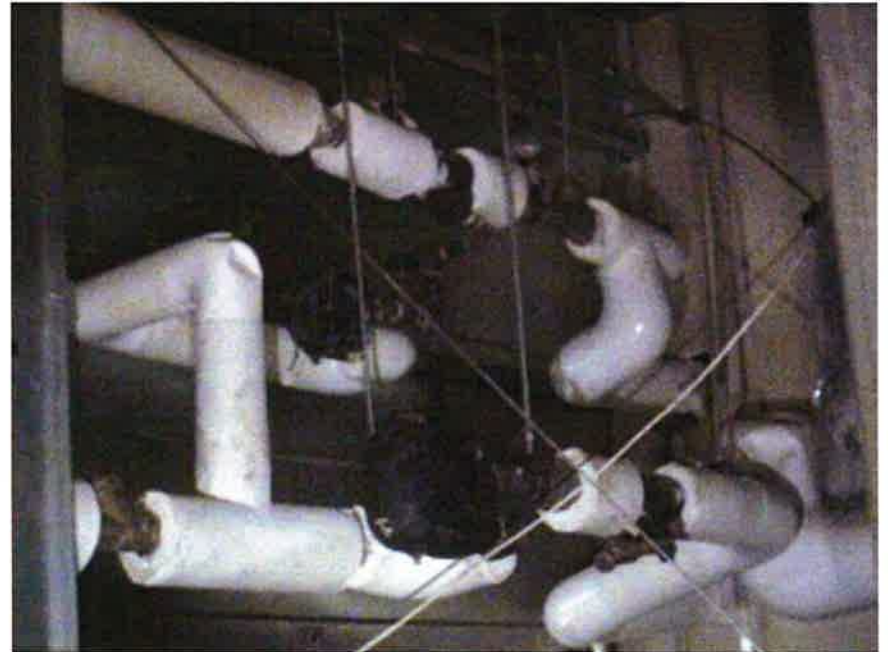
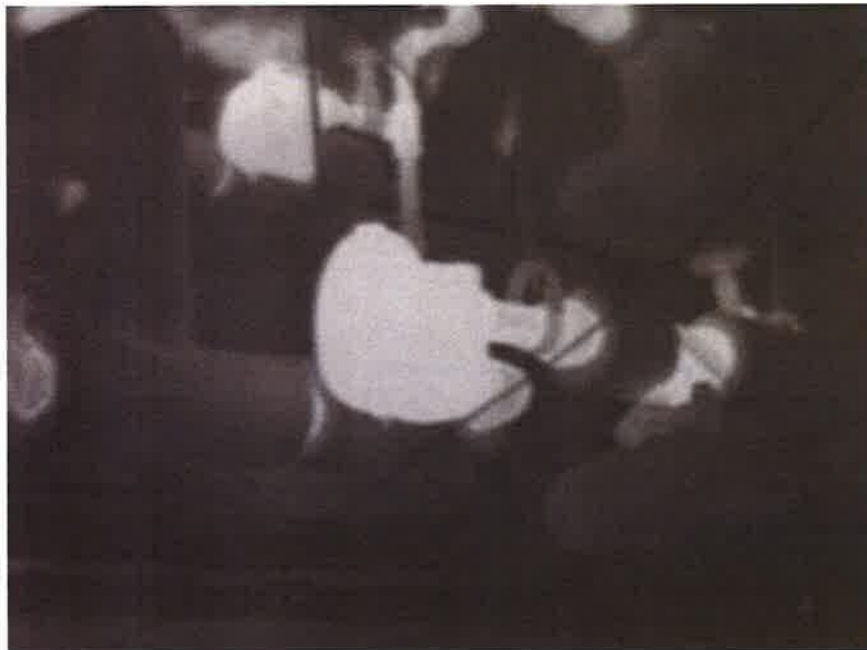
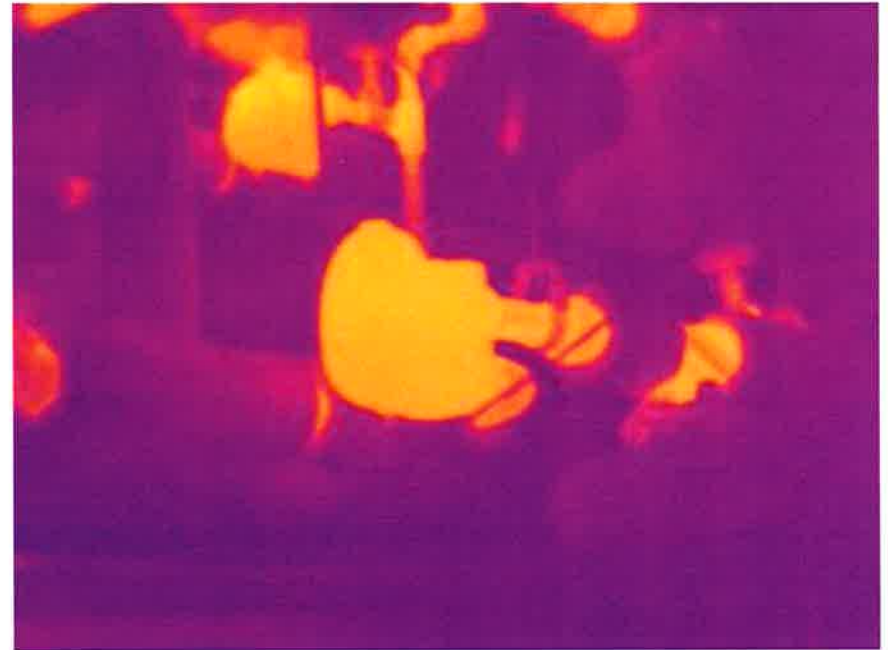
Area/Picture No. 4 Job No. 13-1479.37 Date 2/19/13

Location L22S, ANTI Room Ceiling

Equipment Steam Trap 3"

Comments Trap Temperatures:

Inlet	Outlet
218°F	218°F

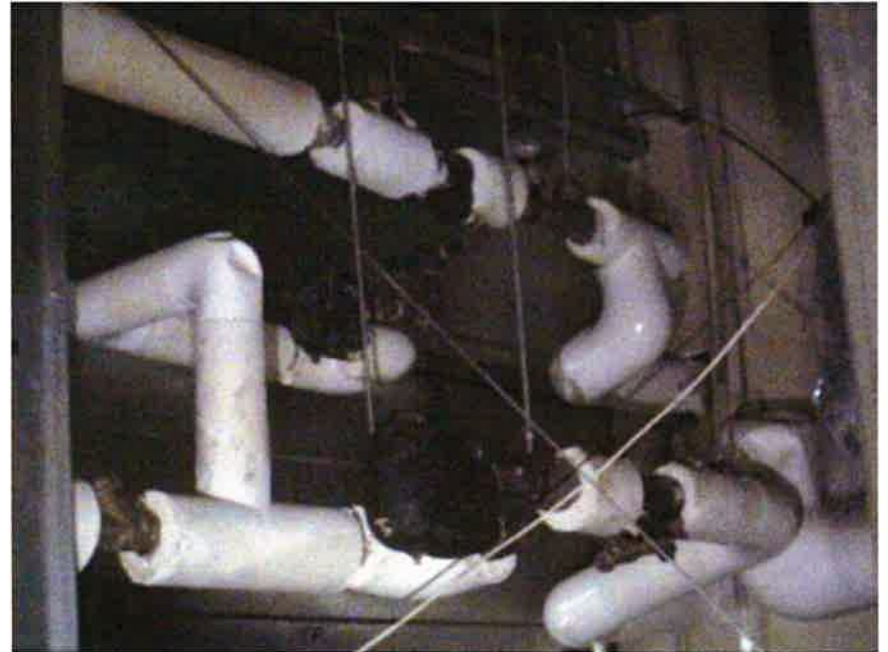
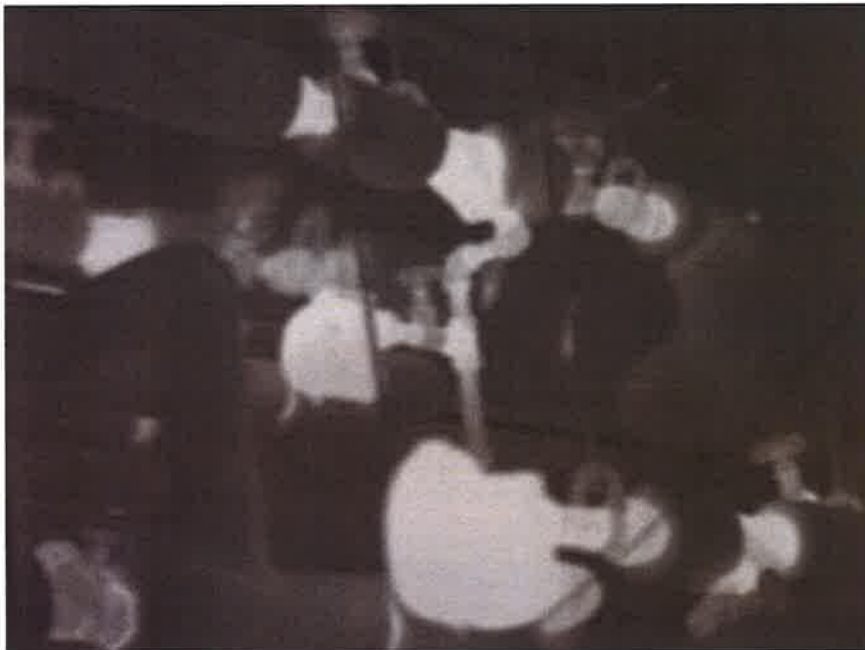
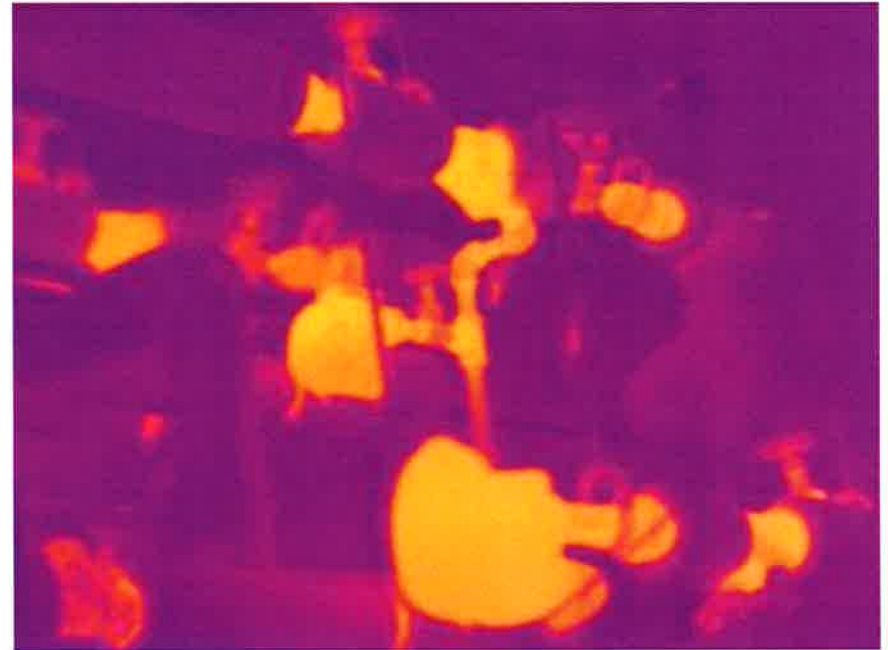
**Area/Picture No.** 5      **Job No.** 13-1479.37      **Date** 2/19/13

**Location** L22A, ANTI Room Ceiling

**Equipment** Steam Trap 3/4"

**Comments** Trap Temperatures:

Inlet	Outlet
218°F	211°F

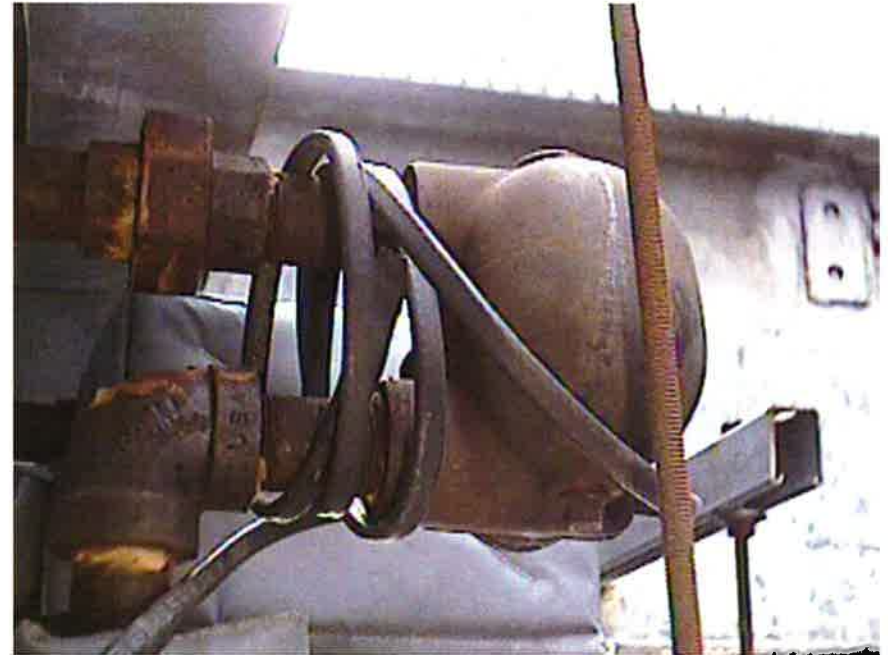
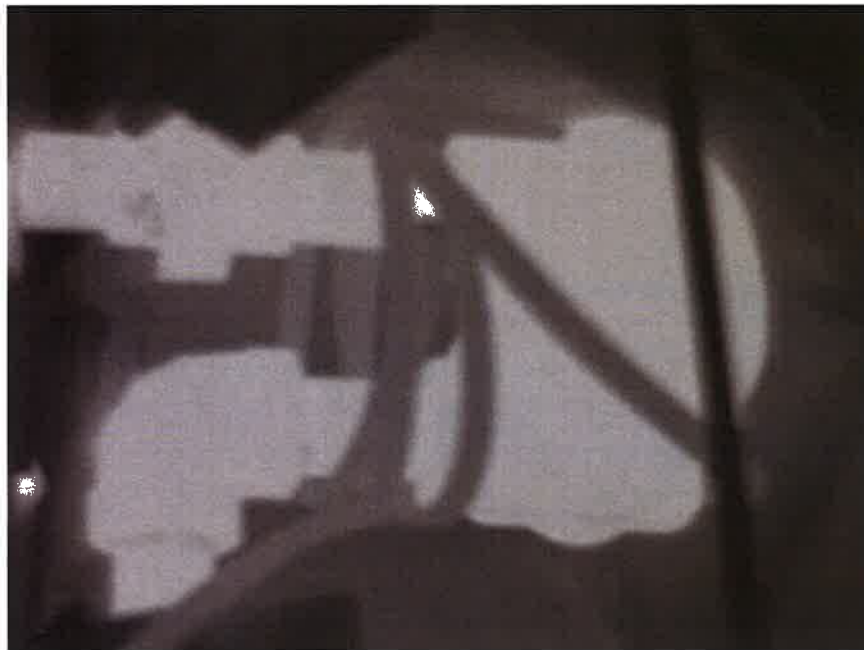
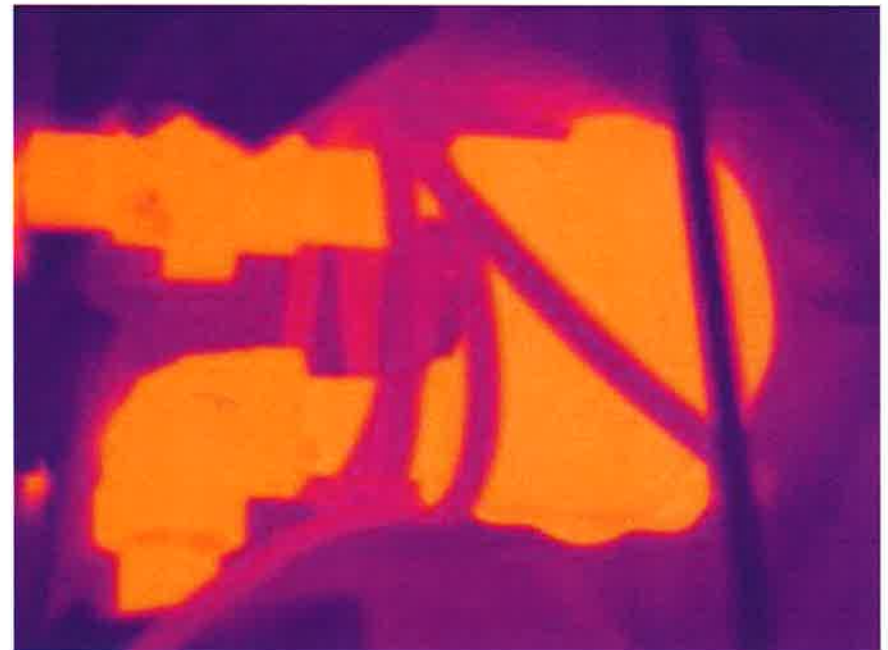
Area/Picture No. 6 Job No. 13-1479.37 Date 2/19/13

Location Roof, Units

Equipment Steam Trap #144

Comments Trap Temperatures:

Inlet 214°F  
Outlet 212°F
