INFRARED FLAT ROOF MOISTURE SURVEY

*ABC Company
123 Main Street
Anytown, USA*

RE: INFRARED FLAT ROOF MOISTURE SURVEY REPORT
OUR JOB NUMBER: 12-2906.4

THERMOGRAPHER'S COMMENTS
OUR JOB NUMBER: 12-2906.4

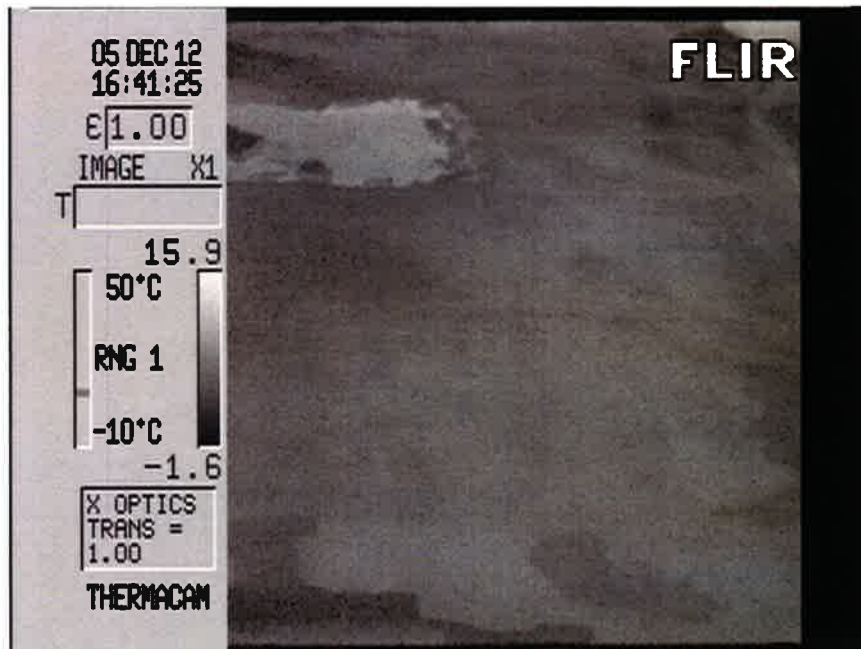
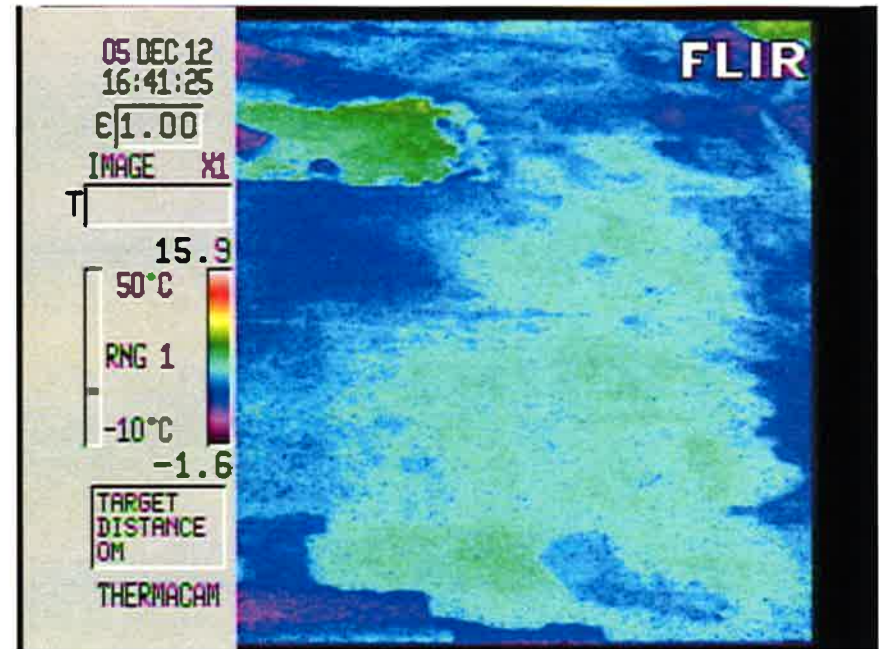
Area/Picture No 1 Job Number 12-2906.4 Date 12/5/12

Ambient Temp 45 °F Location Section A

Damage Type Moisture

Overall size: 1,600 sq. ft. (apx.)

Previously patched: Yes

Blisters present: No

Moisture probe: Positive

Core sample: Positive*

Comments *3 Cores C-1 Pos.
C-2 Pos.
C-3 Neg.

RECOMMENDATIONS: We recommend that the moisture-damaged areas be ripped up and replaced. Should a decision be made to replace only the moisture-damaged areas, an area at least one foot wider than the painted outlines should be replaced to ensure that all moisture damage is removed. Since some of the areas may enlarge by the time repairs are made, the roofer should remove all moisture damage found.

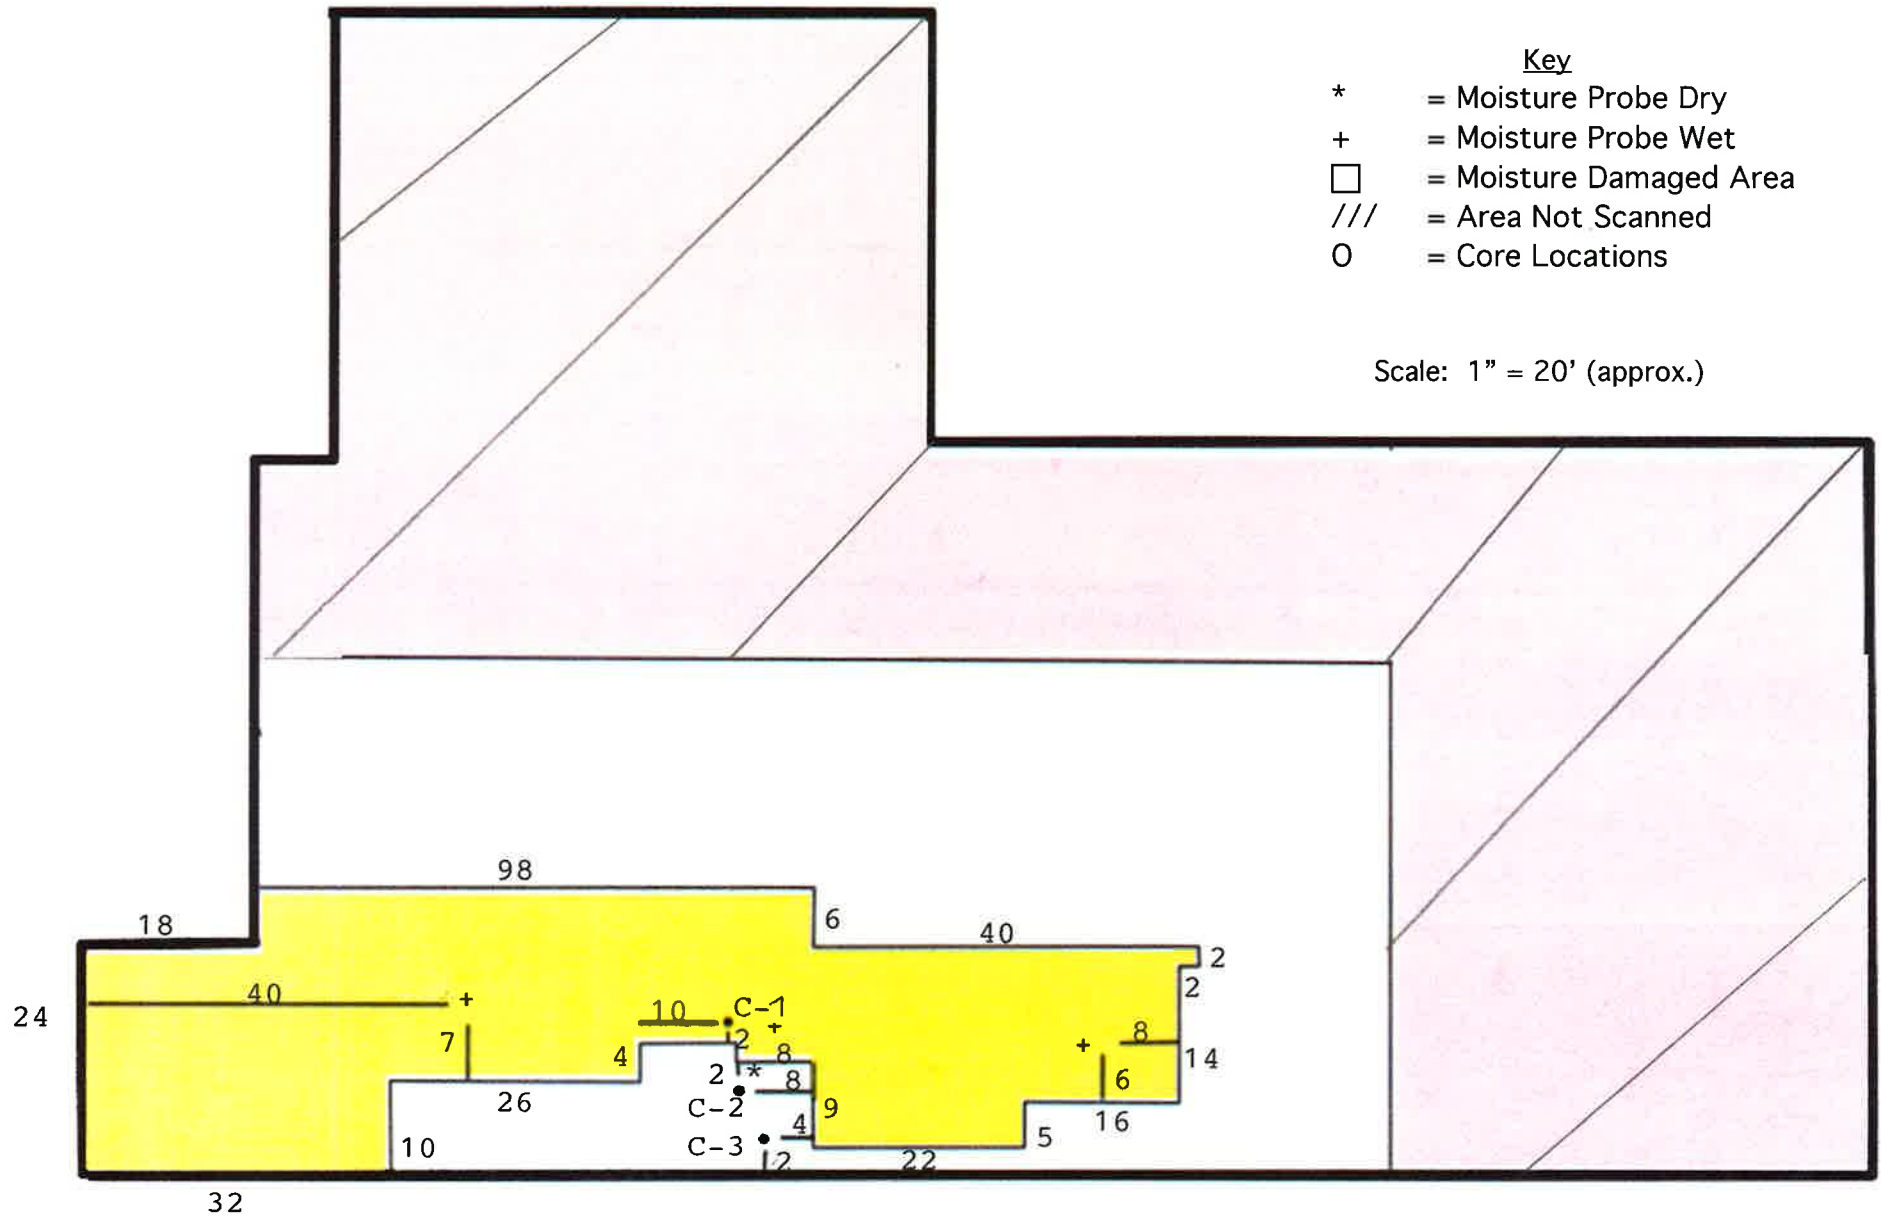
This report contains a scaled map of the roof with the moisture-damaged areas marked in yellow. These yellow areas correspond to the areas of the roofing system which contain moisture. All moisture-damaged areas of the roof are outlined with yellow spray paint on the roof surface. Also included in this report are Thermograms and control photographs of the moisture-damaged areas.

FINDINGS: One area of moisture damage was found on the night of our Survey. Moisture probes confirmed the presence of moisture in the outlined area. The approximate percentage of moisture-damaged roof is as follows:

Section A 22%
